#### Town of Arietta - Board Meeting

Piseco Lake Outlet Dam H&H Modeling Update

David M. Railsback, PE January 16, 2018

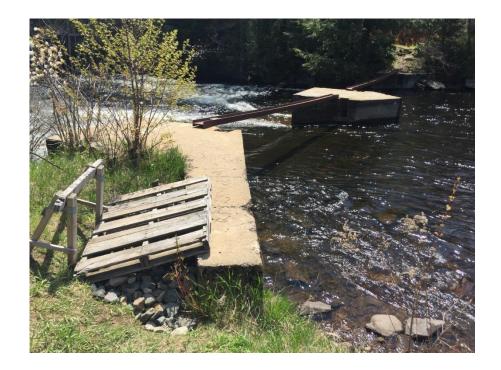
#### Condition of Dam

- Seepage at Left Abutment
- □ Concrete Deterioration
- Erosion
- Lake Level Management
- Operations and Public Safety
- Regulatory Compliance
  - Environmental Stewardship

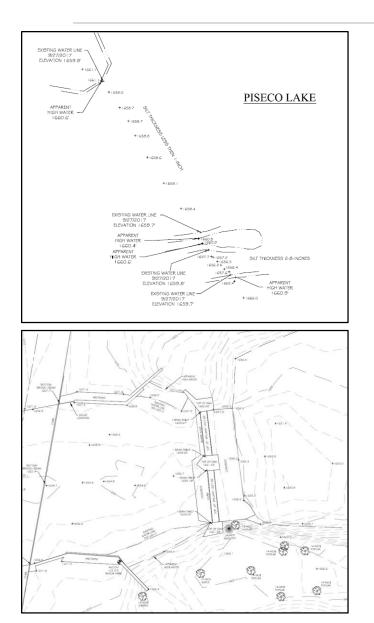
## Survey Results

- 8 Cross Sections from Lake to Dam
- Dam Site Details
- Staff Gauges
  - Lake staff gauge zero mark: EL 1660.626 ft (NAVD 88).
  - Established an additional staff gage on the upstream side of the dam's left abutment, with a zero mark level with the spillway crest at EL 1657.46 ft.

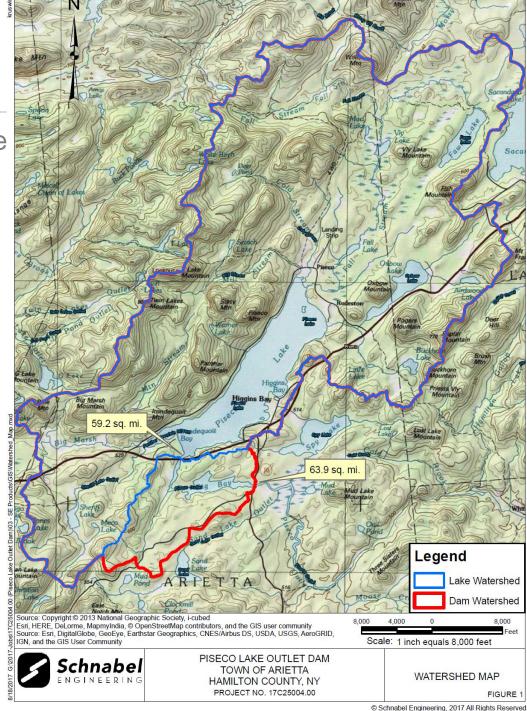
## Watershed Information

- 59.2 sq. mi. at Route 10 Bridge
- 63.9 sq. mi. at Dam
- 19% of watershed is lakes/wetlands
  - 80% Forest Land
  - 1% Developed/Urban Land

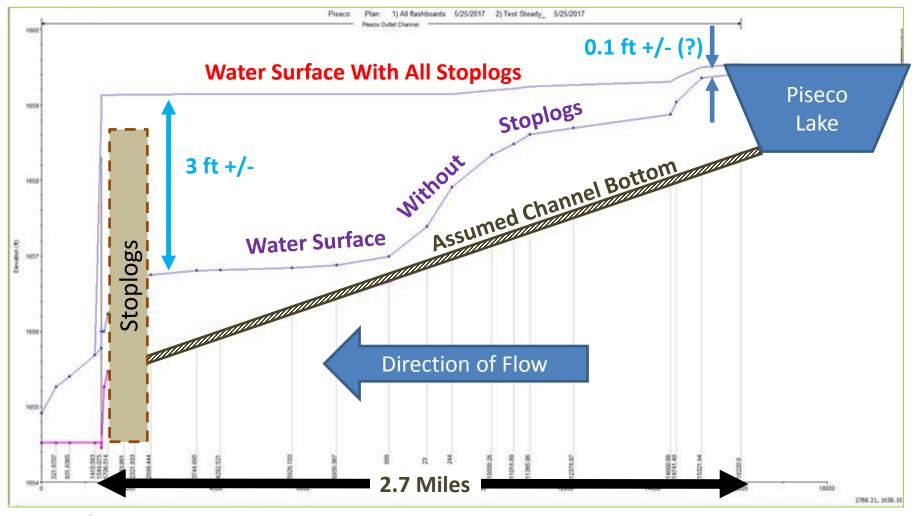
# **Preliminary Model**

Dam / Route 10 Big Bay Narrows (Boulder Channel)

Route 8

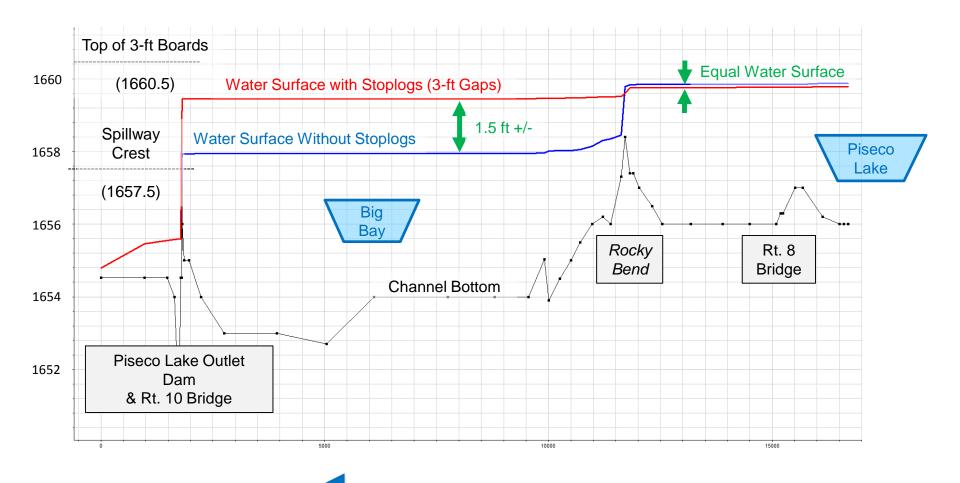
## **Refined Model**

50 Cubic Feet per Second (Low Typical Flow)

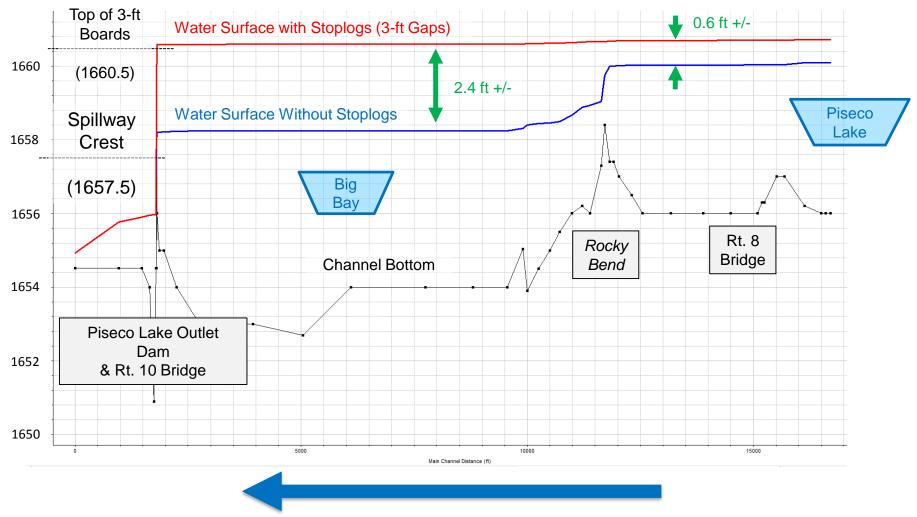
## **Refined Model**

100 Cubic Feet per Second (Moderate Typical Flow)

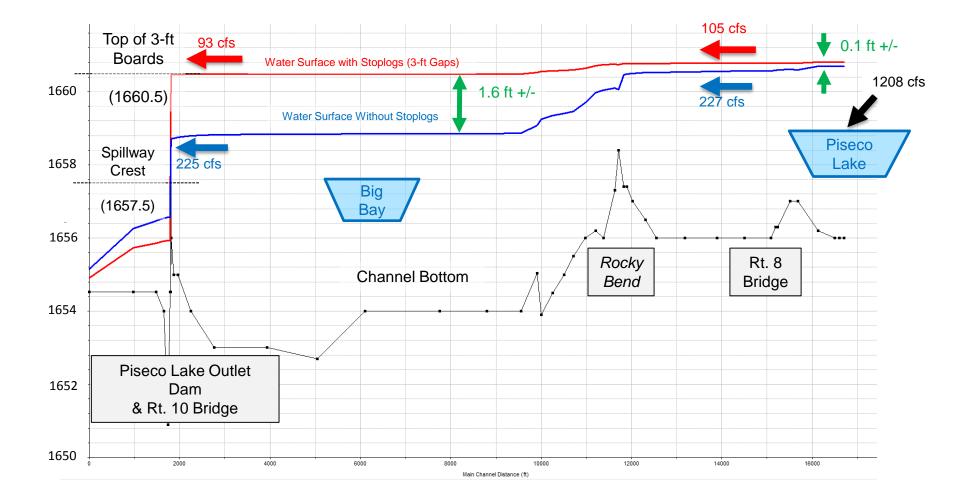
#### 1-Year Storm (2.5 inches of rain in 24 hours) 1208 CFS Runoff to Lake

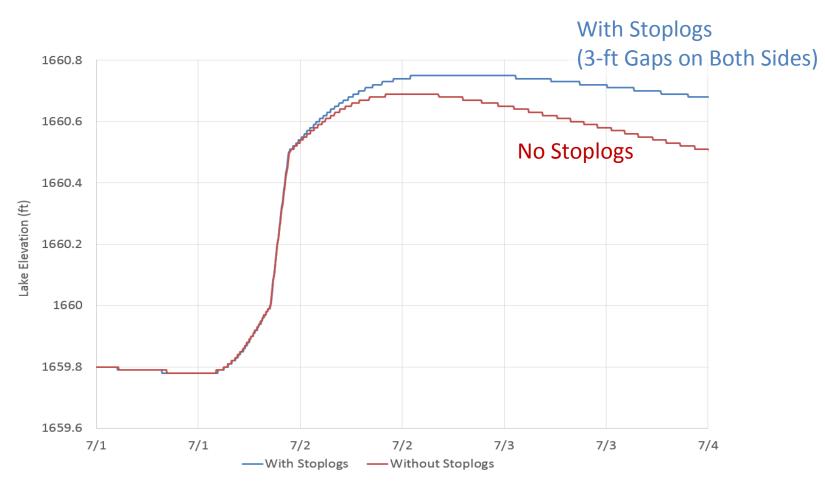
## Modeling for Long-Term Trends

- DEC Dam Safety requires a event-based storm evaluation (i.e. 100-yr storm).
- Additional value for the Town in a long-term model.

#### 1-Yr Storm (2.5 inches in 24 hours)

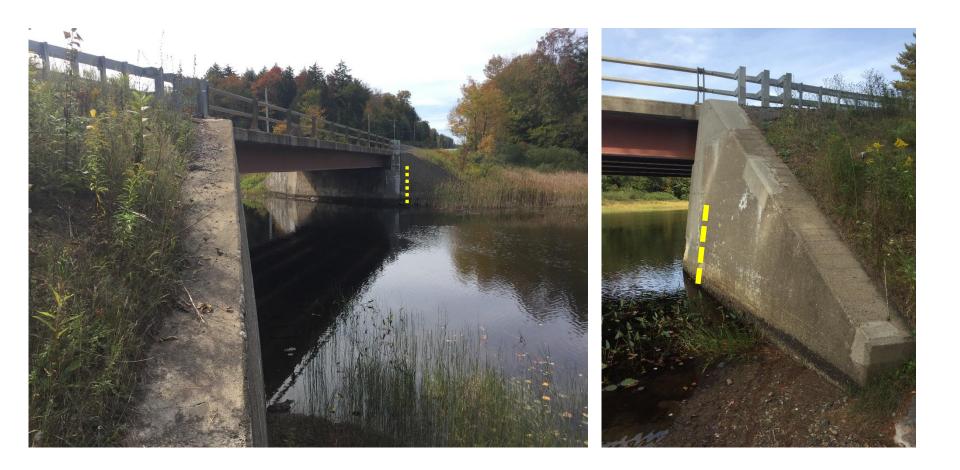
#### Additional Gauge on Route 8 Bridge

- Optimize the stoplog configuration (short-term).
- Additional staff gauge at Rt. 8 Bridge and benchmark at boat ramp.
- Automated data collection.
- Geotechnical maintenance work at left abutment.
- Model calibration for long-term trends.
- Optimize stoplog configuration for long-term.
- Evaluate flow control alternatives at dam (gates?).
- Evaluate other dam locations.

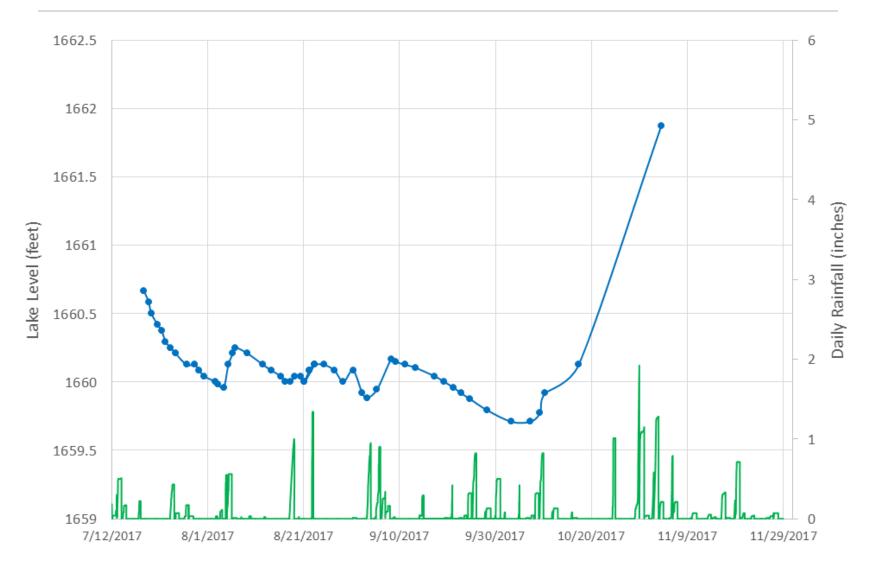
### Model of Long-Term Trends

Observed Lake Level

- Rainfall
